Tech Tip: Check Those Cross-members!!

by Frank Philippi

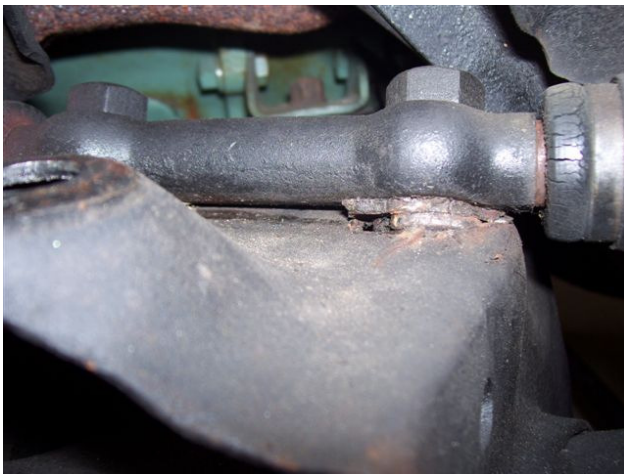
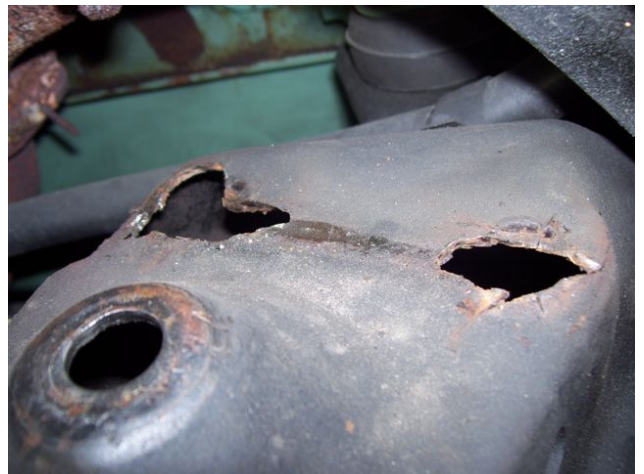
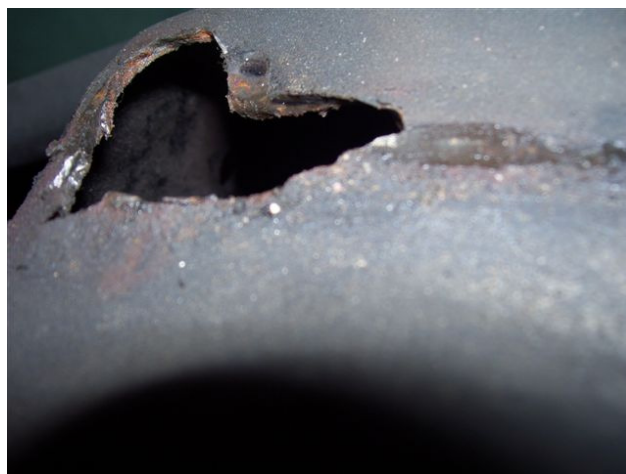
It's well known that Studebaker's frames in the 1950s were lighter than they should have been. Apart from the flexing evident on certain models, especially 1953 Hardtops, another problem that cropped up was tearing, cracking, whatever you want to call it, where the upper inner control arm mounts to the front cross-member. Studebaker eventually recognized this as a problem and later issued a service bulletin (#358) that describes a field repair, essentially a reinforcing plate to be welded in to the cross-member where the upper control arm is bolted on. Why do I bring this up? Take a look at the following pictures. This is the cross-member on my '56 President and was recently discovered in the process of having other work done. A scary sight, eh? Especially considering I've recently driven this car at 70 mph. While the service bulletin says this is only a problem on high mileage and severe service vehicles, this President is a 65,000 mile car that spent its entire life in the Shenandoah Valley, not on back roads in Mexico. So do yourself a favor—take a close look at that area of the cross-member and look for any signs of cracking. The life you save may be your own!
